RAU Staff Soil Sampling, Treasure Island, Site 12

March 20-21, 2013

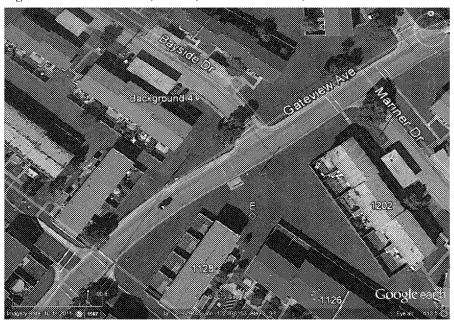
Figure 2: Treasure Island, Site 12, Gateview Avenue, Location 2

Location 2 was in a green belt area southwest of the intersection of Gateview Avenue and Bayside Drive. One elevated measurement was found in this location.

Sample E was in the a greenbelt area southwest of the intersection of Gateview Avenue and Bayside Drive, approximately 6.1 meters (20 feet) from a bus stop bench, see Figure 2: Treasure Island, Site 12, Gateview Avenue, Location 2. Exposure rate measurements made at the location are summarized in
